PROJECT: Midnite Mine Remediation

REPORT NO: 2019-017

Summary of Work Activities or Events for this reporting period:

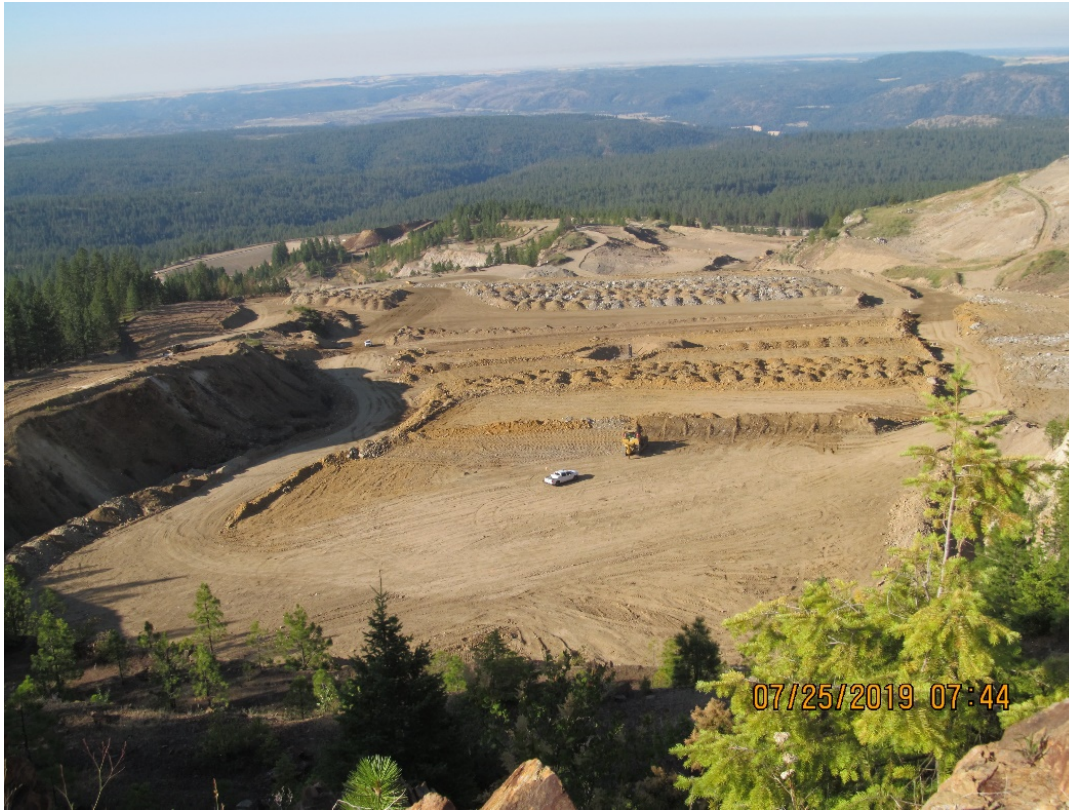
Figure 1 - Overview of Pit 4, Looking South

- Continued excavating, hauling and placing low activity/low reactivity material to Pit 4 from South Waste Rock Pile (SWRP) west of the South Pond and SWRP North. Material from SWRP was placed on the north, east, and west sides of Pit 4 to create the 20' rind buffer area, at the south end of the Pit 4 backfill to form the 20' radon buffer on the outer waste surface, and in the unclassified waste zone in the interior of the pit.

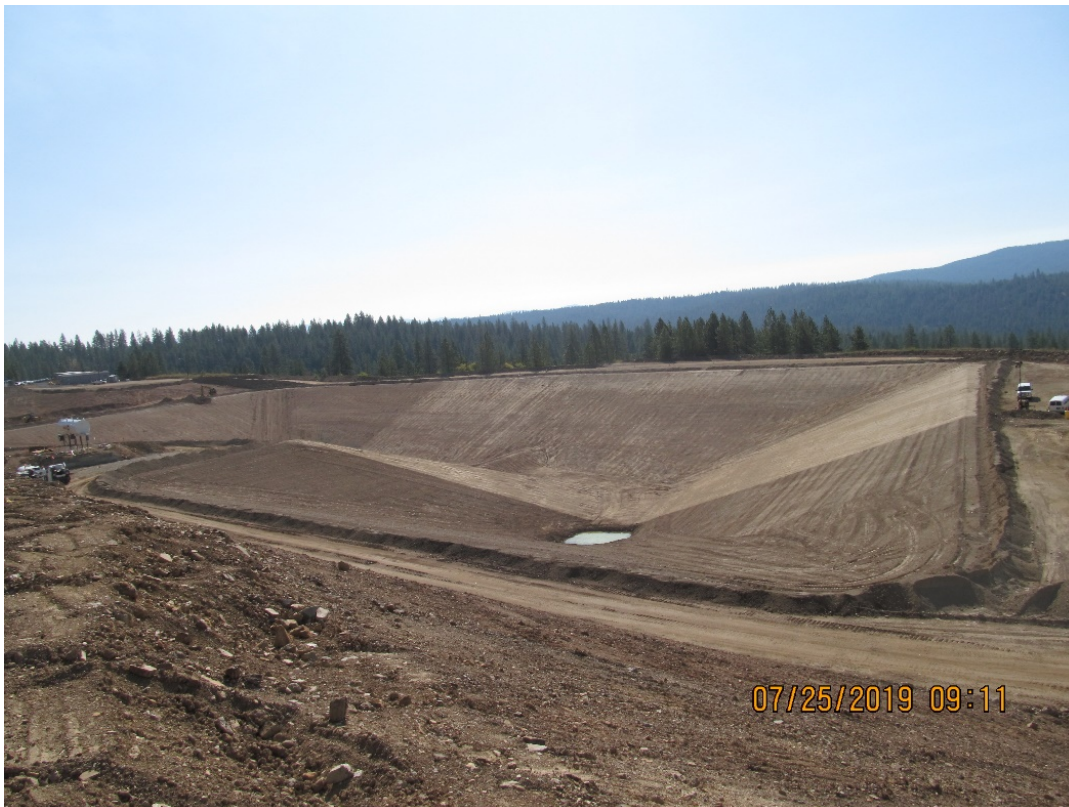
Figure 2 - South Pond, Looking Southeast

- Continued to shape smooth the South Pond on the SWRP to final grade, continued pulling rocks from the surface and placed drain gravel in the seep collection sump.
